Notice to Navigation Interests

Lake Erie, Ohio

Condition of Federal Navigation Channel Conneaut Harbor, Conneaut, Ohio

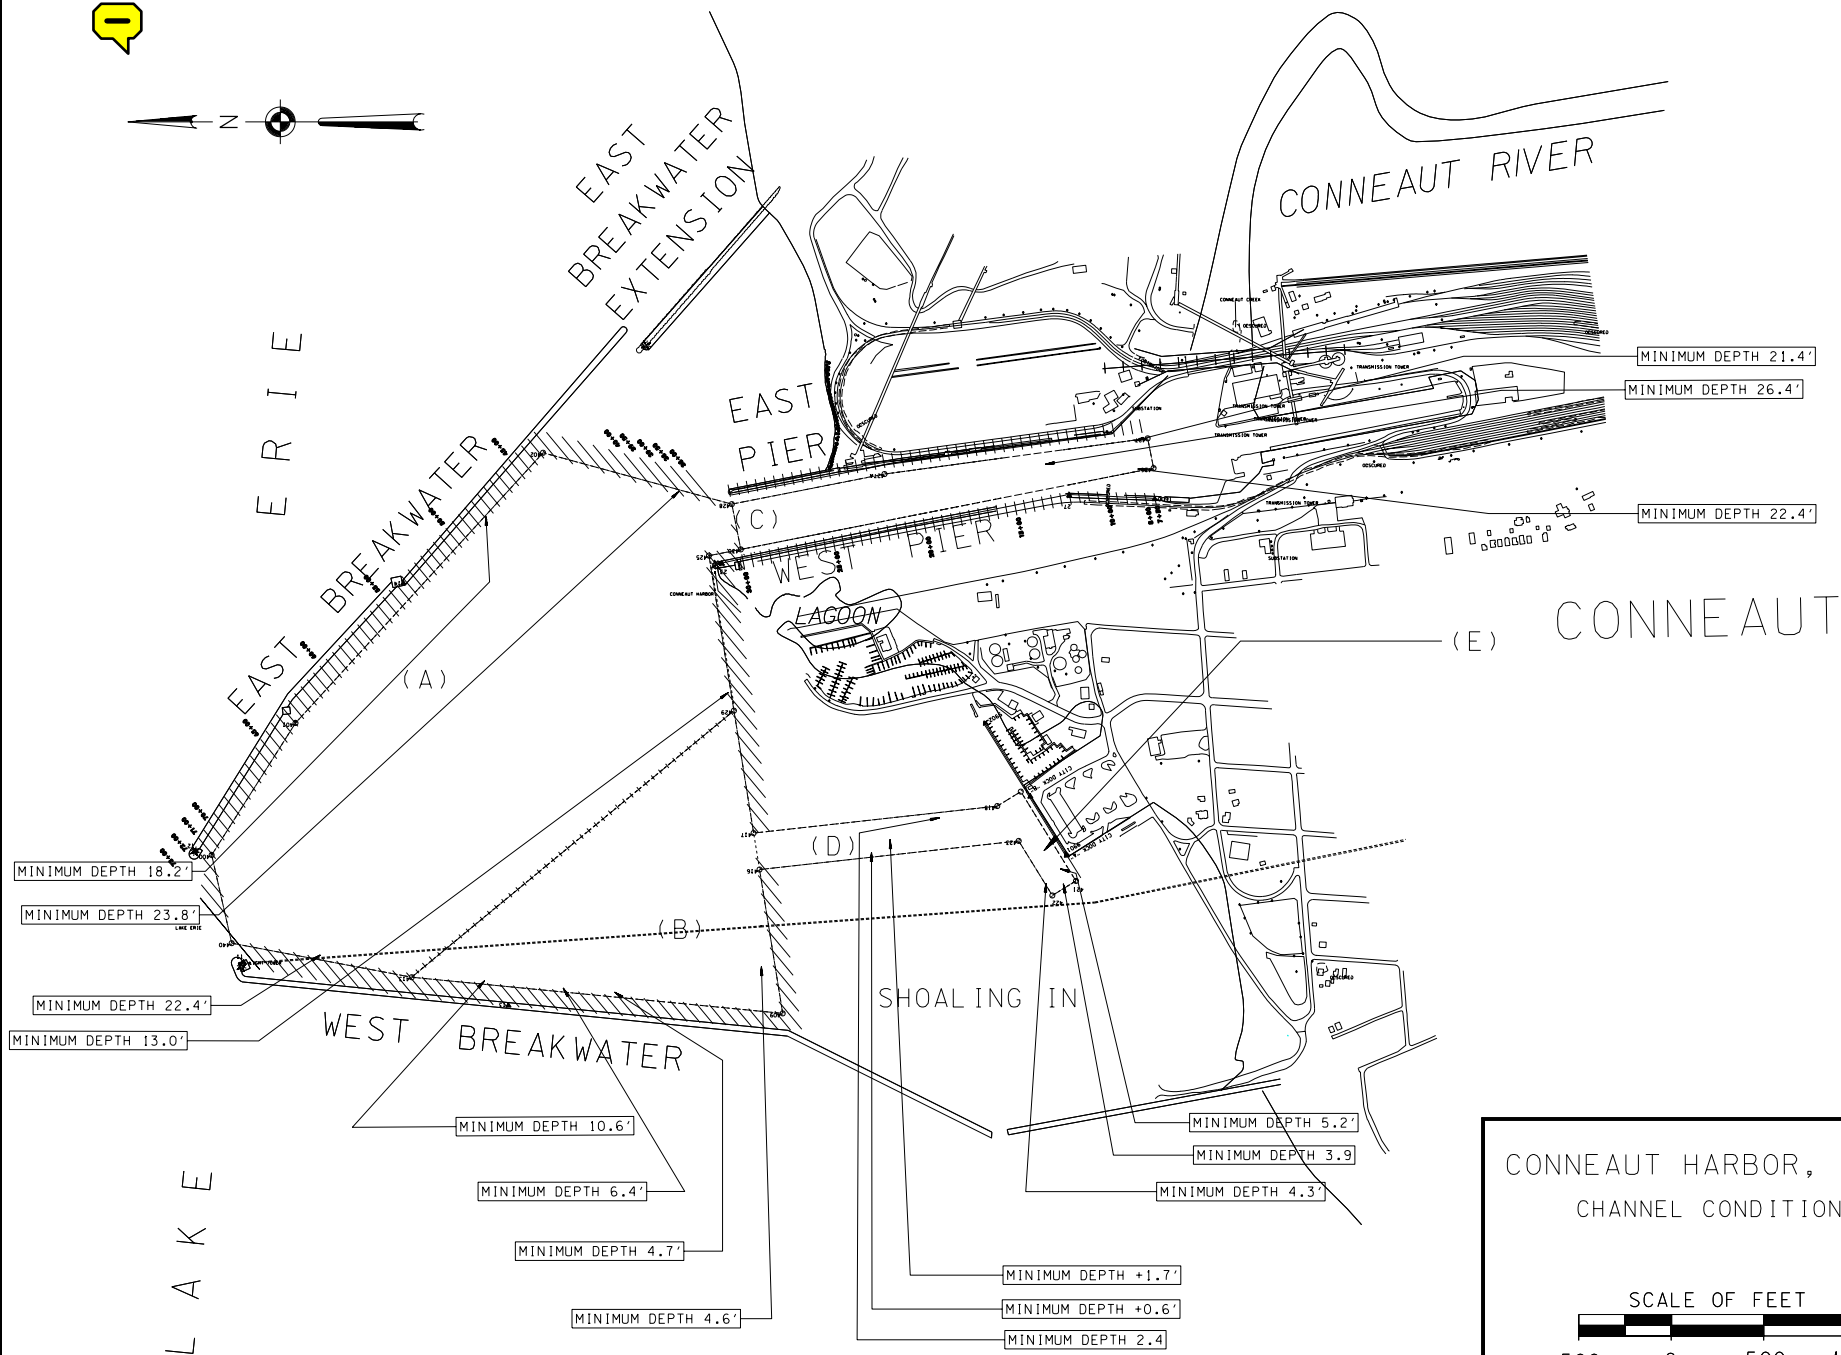
CONNEAUT HARBOR, OHIO
CHANNEL CONDITIONS

1. Condition surveys performed within the Federal navigation Channel at Conneaut Harbor, Ohio during the months of August and September 2003 indicate shoaling has reduced depths to those shown on the attached standard tabular form and channel condition drawings.

3. Vessel operators are advised to use caution when navigating in this area.
4. Copies of the sounding print for Conneaut Ohio consisting of (1) sheet, 03S-CON-1/1, at a cost of \$2.50 per sheet will be furnished upon receipt of a check in the full amount made payable to: United States Army Engineer District, Buffalo. Requests should be addressed to: District Commander, U.S. Army Engineer District, Buffalo, ATTN: NY/PA O&M Office, 1776 Niagara Street, Buffalo, New York 14207, requesting exact number or copies of sheets by file number. A point of contact and phone number must be indicated to facilitate response to the request. To obtain the Metadata and CADD files and view a color version of this map, point your web to <http://www.lrb.usace.army.mil/waterways/survey/survey.html>. Click on the link "SURVEY SECTION" to send a message containing your request.
